UAS MODELING OF DINOSAUR RIDGE, CO – ROCKFALL HAZARD SURVEY

UAS PROJECT INFORMATION

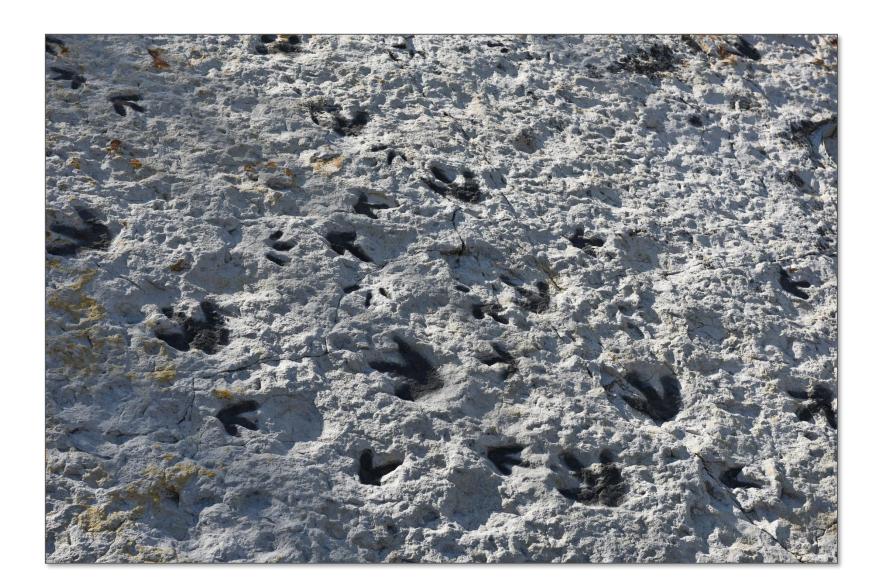
Photo: Cretaceous iguanodon and theropod tracks on the east side of Dinosaur Ridge

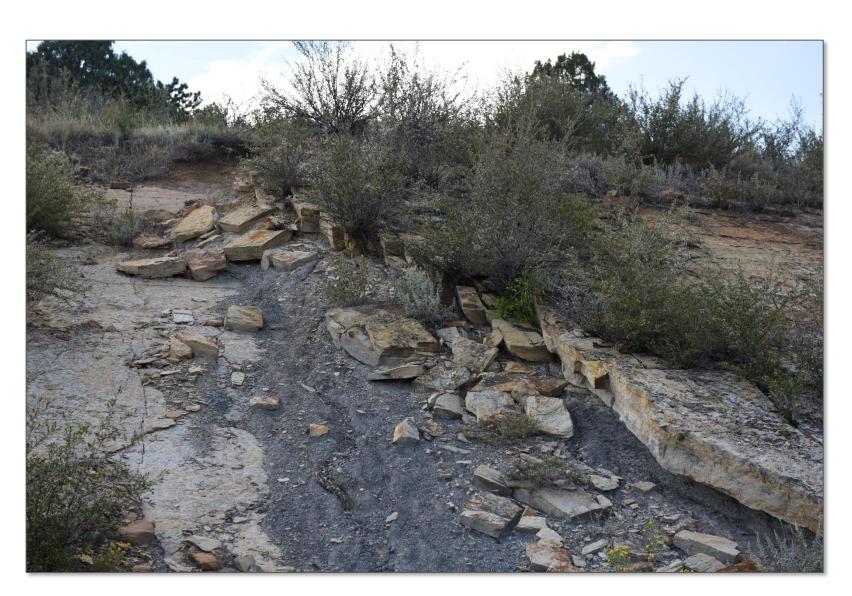
Photo: Loose rocks of the Dakota Formation hang on a 30 degree slope near the dinosaur ridge trackway

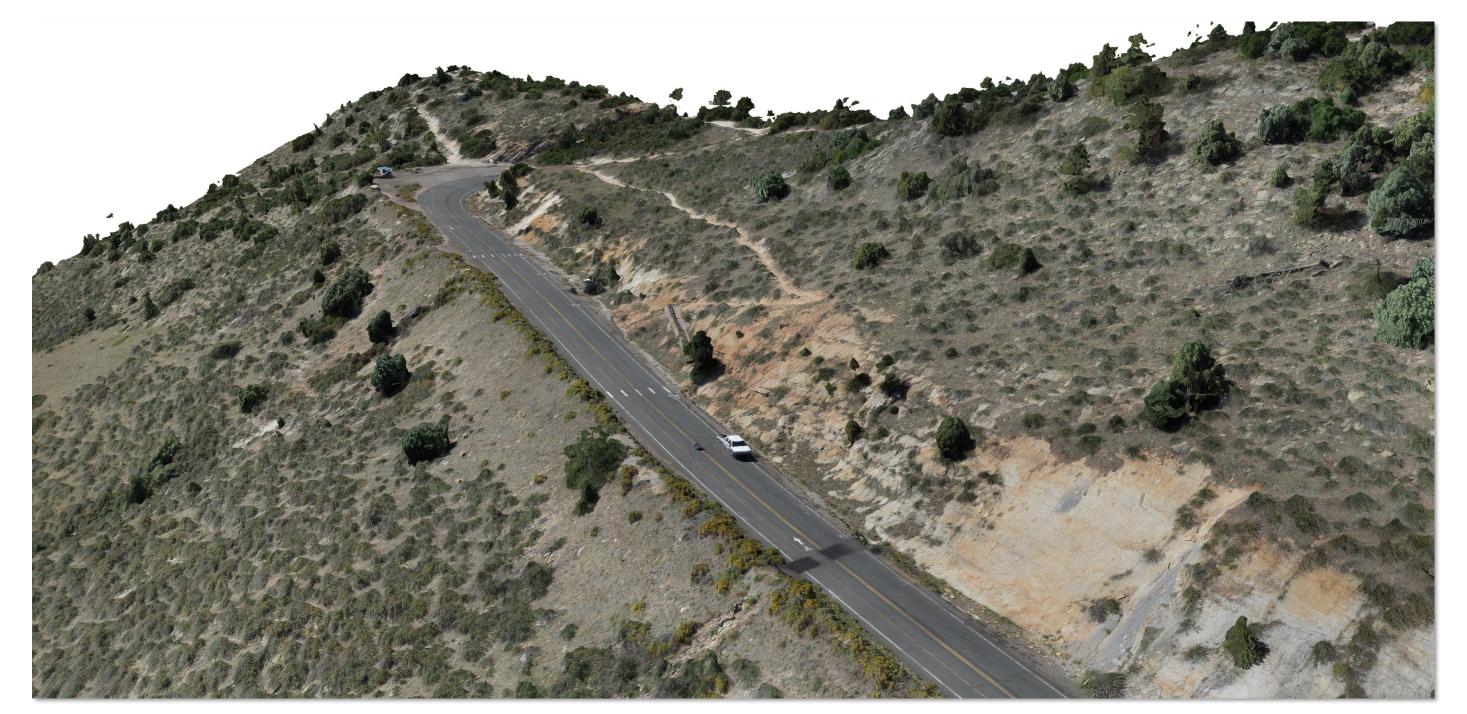
3D textured surface model of Dinosaur Ridge taken with the Ricoh GR II camera

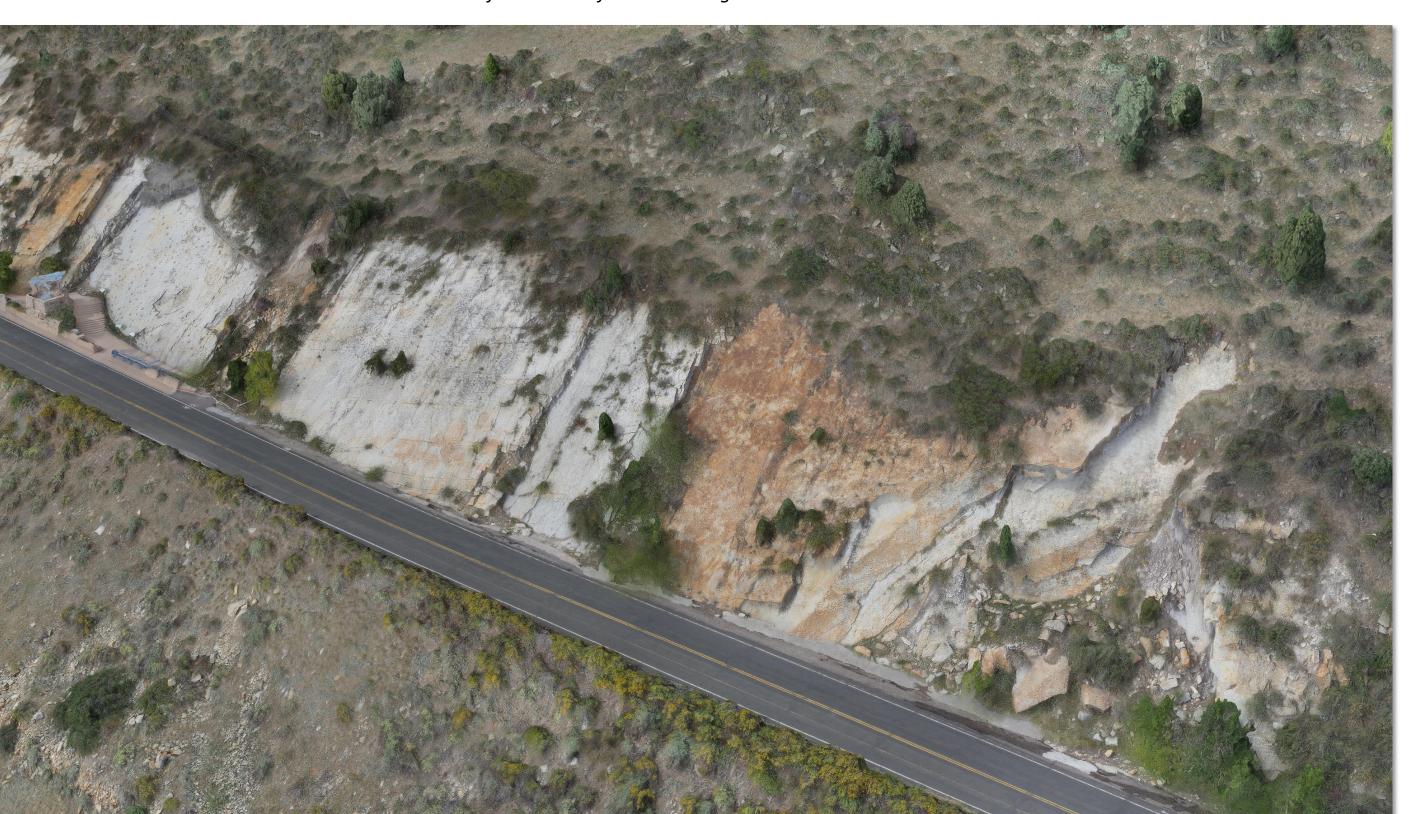
Slope calculations (in degrees) generated from the UAS Digital Surface Model (DSM)

3D textured surface model of Dinosaur Ridge taken with the Ricoh GR II camera
